TECHNICAL NOTE 3190

FATIGUE INVESTIGATION OF FULL-SCALE
TRANSPORT-AIRPLANE WINGS

SUMMARY OF CONSTANT-AMPLITUDE TESTS THROUGH 1953

By M. J. McGuigan, Jr., D. F. Bryan, and R. E. Whaley

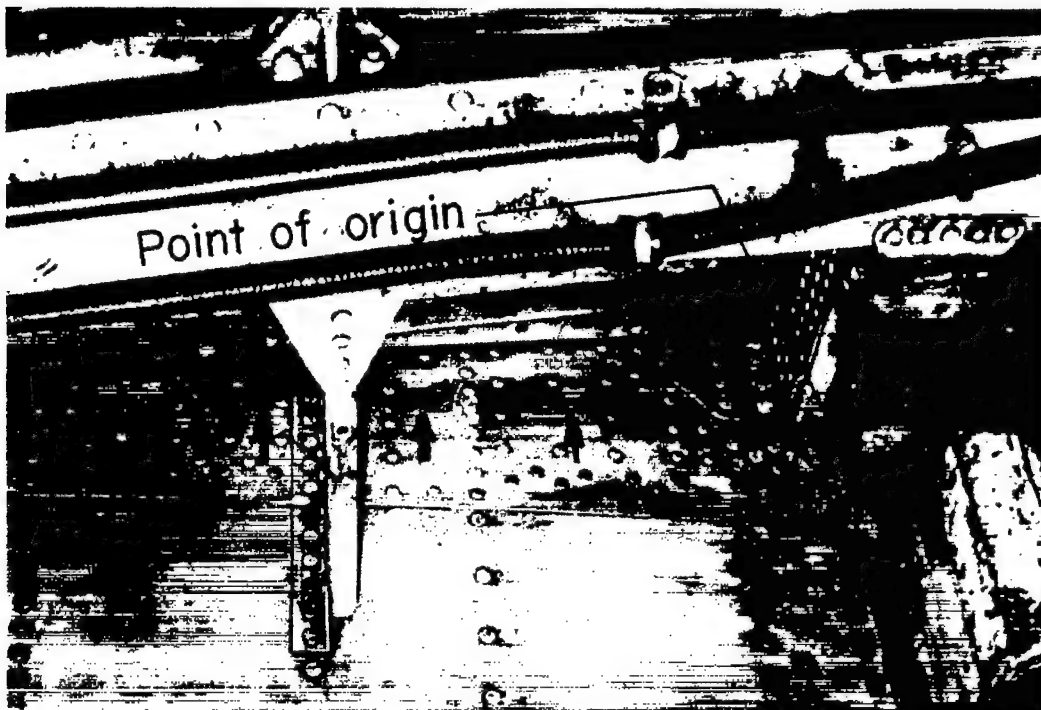
L-67783.1

Type V includes all the failures that could not be classified in one of the preceding types. Several failure locations are included in this type, but at only three of these did failures repeatedly occur. One of these locations was in a joggle in an external doubler plate about 3 inches outboard of the wing attach angle and directly over the 30-percent spar. These failures occurred only at the two highest load levels and an example is presented in figure 6(e). Another type V failure occurred in the skin at the edge of the external attach-angle doubler plate, between the 30-percent spar and cutout B. A photograph of this failure location is presented as figure 6(f). Strain-gage measurements indicated this region to have a higher nominal stress than any other location where strain-gage measurements were made. These failures occurred at every test level. Another failure location of type V was inside the engine nacelles at span station 180 in a doubler plate over the front spar. A notch had been cut in the edge of the doubler plate to allow clearance for the rotation of the landing-gear strut during extension and retraction of the landing gear, and the failures started either in the notch or at a rivet near the notch. In some cases the notch had been hand cut and in others the notch was cut by rotation of the landing-gear strut itself. A photograph of this failure is presented as figure 6(g).

- (g) Type V failure inside engine nacelle.
